Debris/Ice/TPS Assessment and Integrated Photographic Analysis of Shuttle Mission STS-94

**DEBRIS/ICE/TPS ASSESSMENT
AND
INTEGRATED PHOTOGRAPHIC ANALYSIS
OF
SHUTTLE MISSION STS-94**

1 July 1997

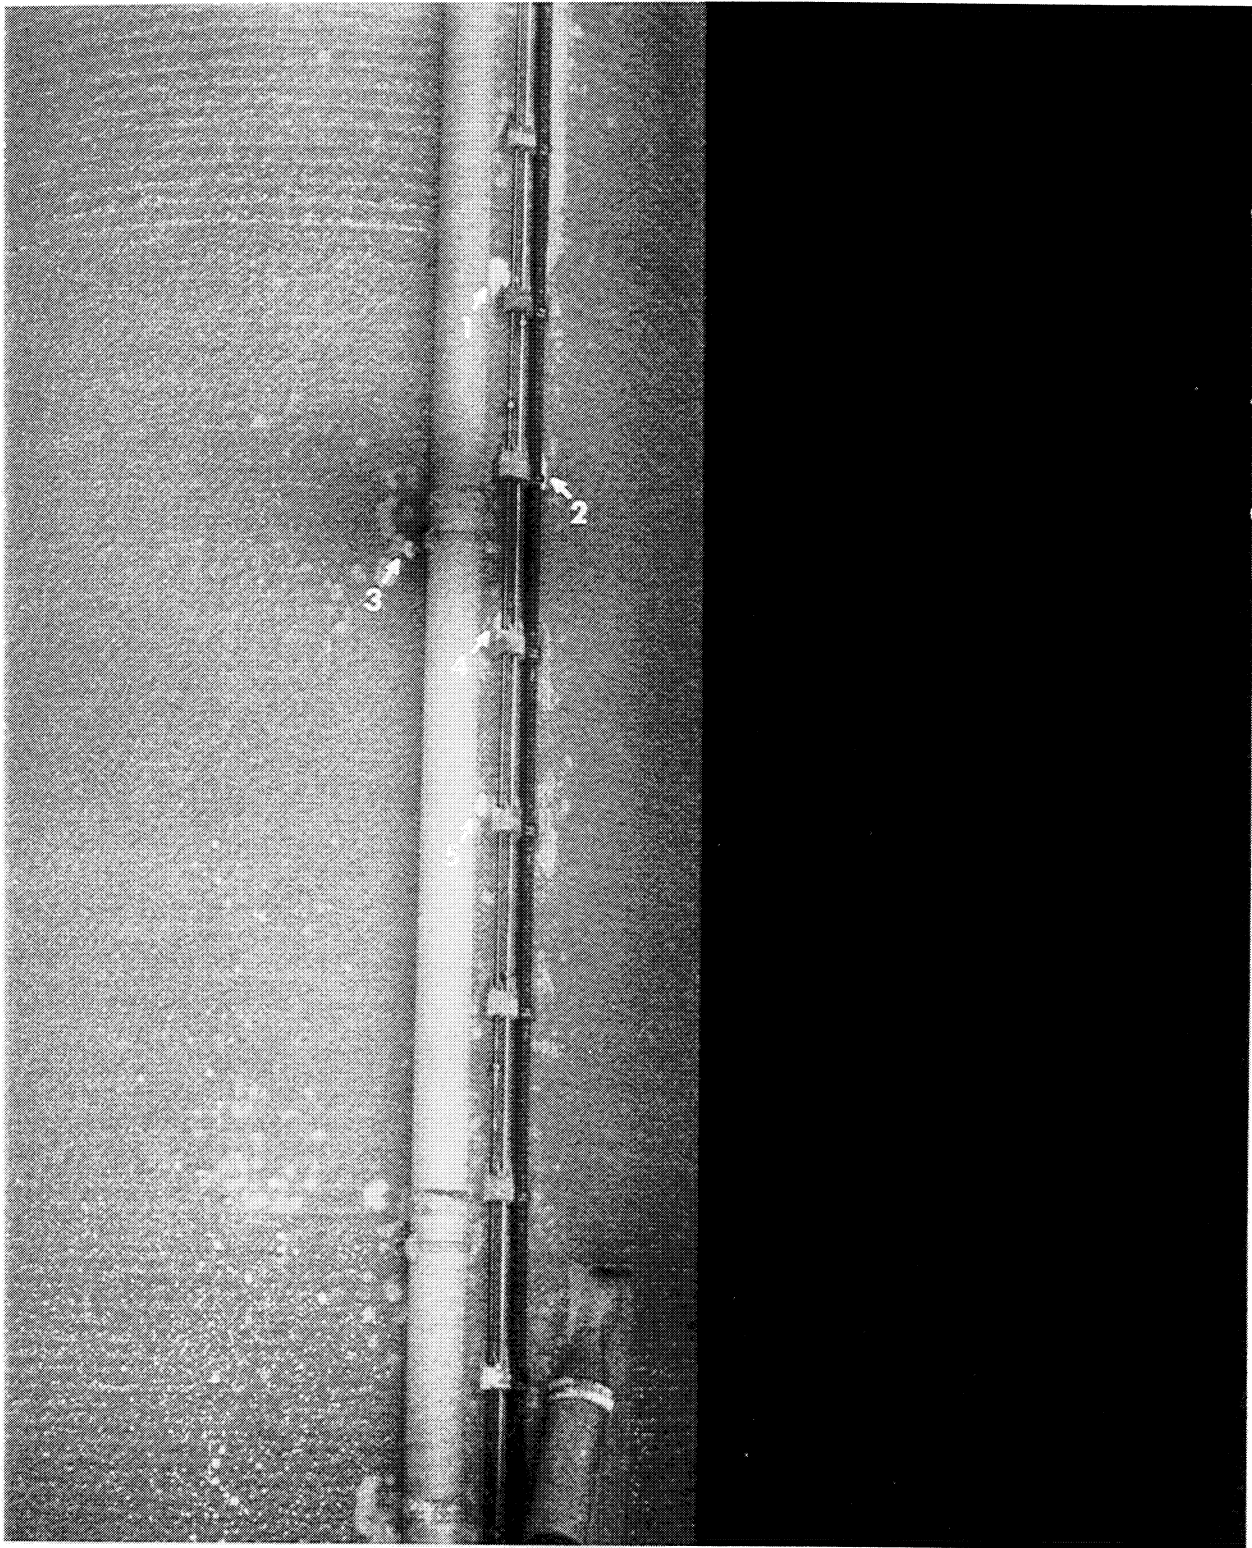
Photo 13 : ET LH2 Tank TPS Divots

Several divots were detected in and around pressurization line and LO2 feedline supports: (1) a shallow 16-inch long by 10-inch wide divot in the LH2 acreage between the pressurization line and the LO2 feedline at station XT-1528; (2) a 14-inch long by at least 2-inch wide divot outboard of the XT-1593 pressurization line ramp; (3) a 5-inch diameter divot (possibly with primer showing) adjacent to the XT-1623 LO2 feedline inboard support; (4) a 4-inch by 2-inch divot at the leading edge of the XT-1657 pressurization line ramp; (5) and a shallow, 6-inch by 4-inch divot in the LH2 tank acreage between the pressurization line and the LO2 feedline at station XT-1722.

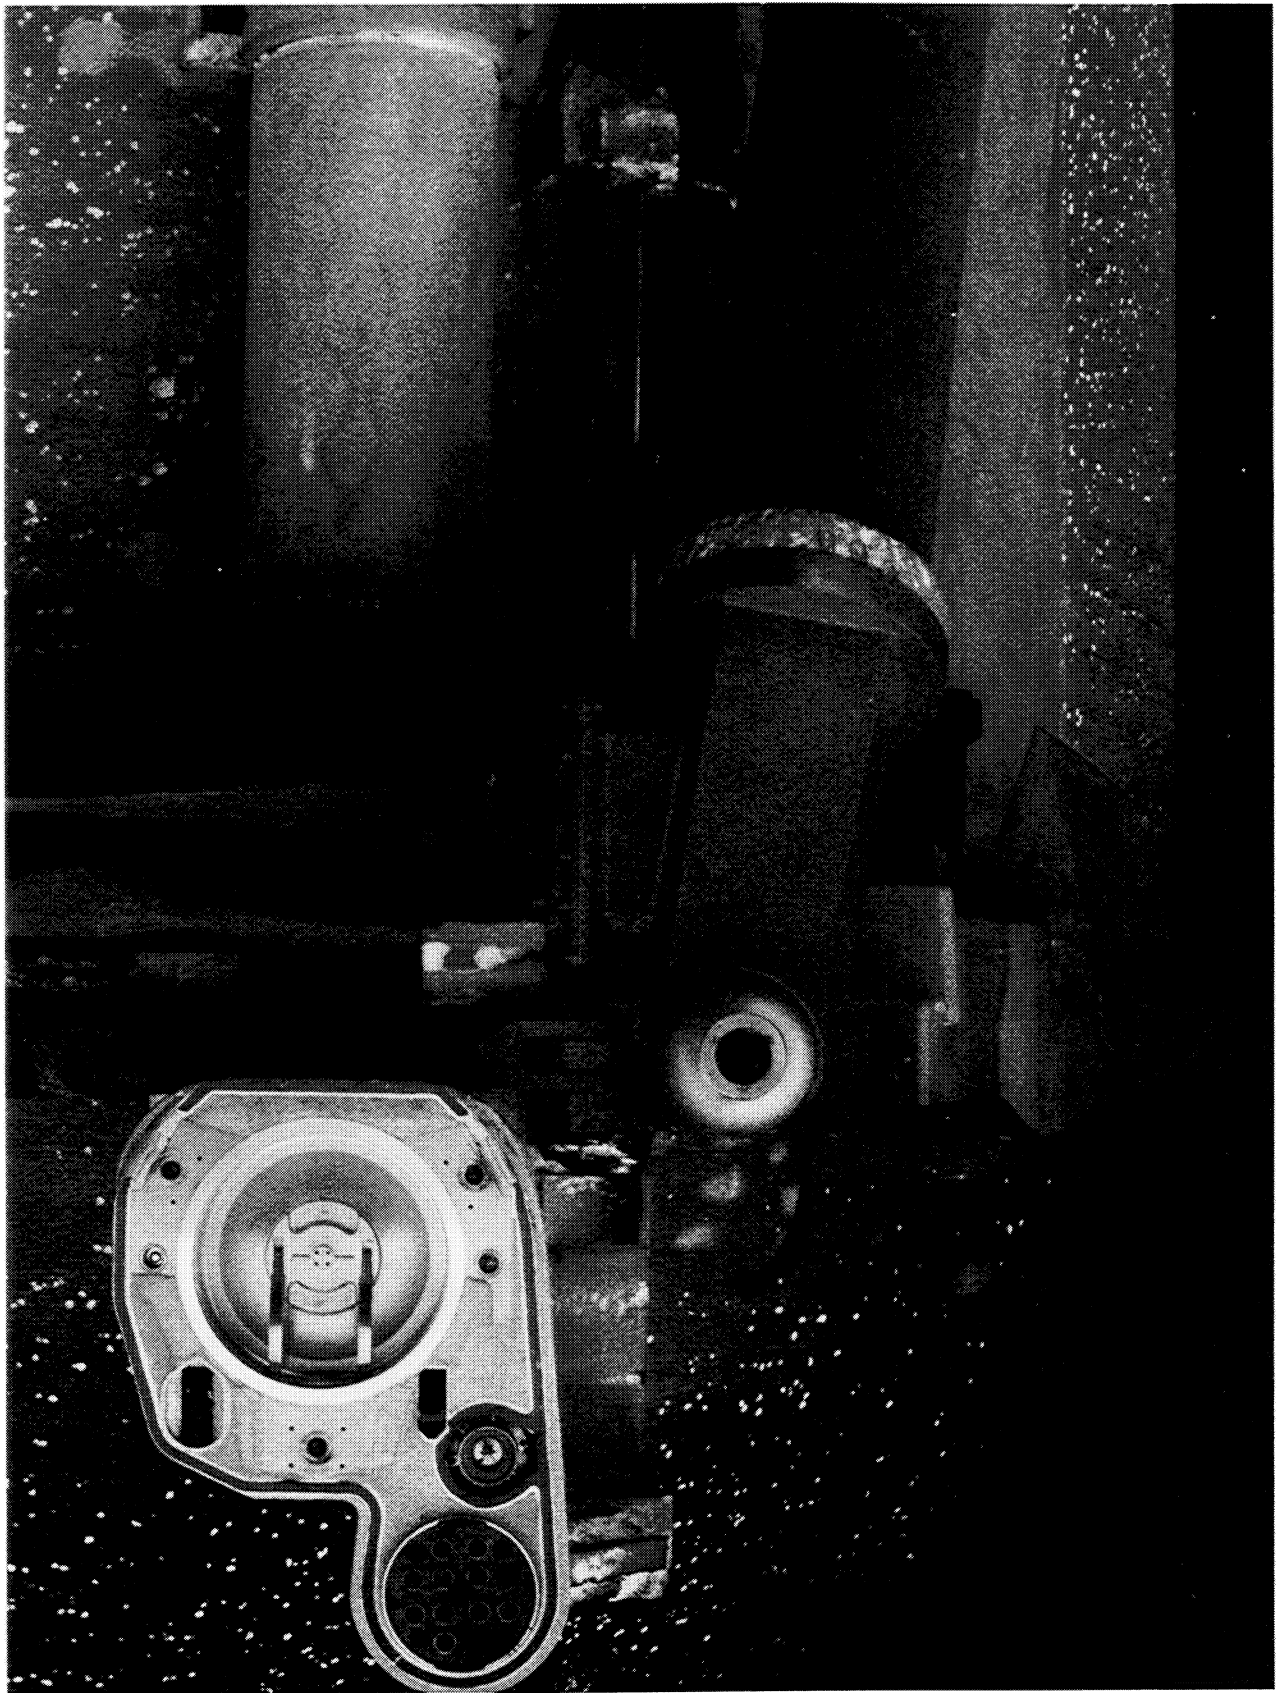
Photo 14 : ET/ORB LO2 Umbilical

The LO2 ET/ORB umbilical sustained no visible TPS damage during separation. Numerous divots and eroded areas were visible on the horizontal and vertical sections of the cable tray. The red barrier around the EO-3 fitting was dislodged.

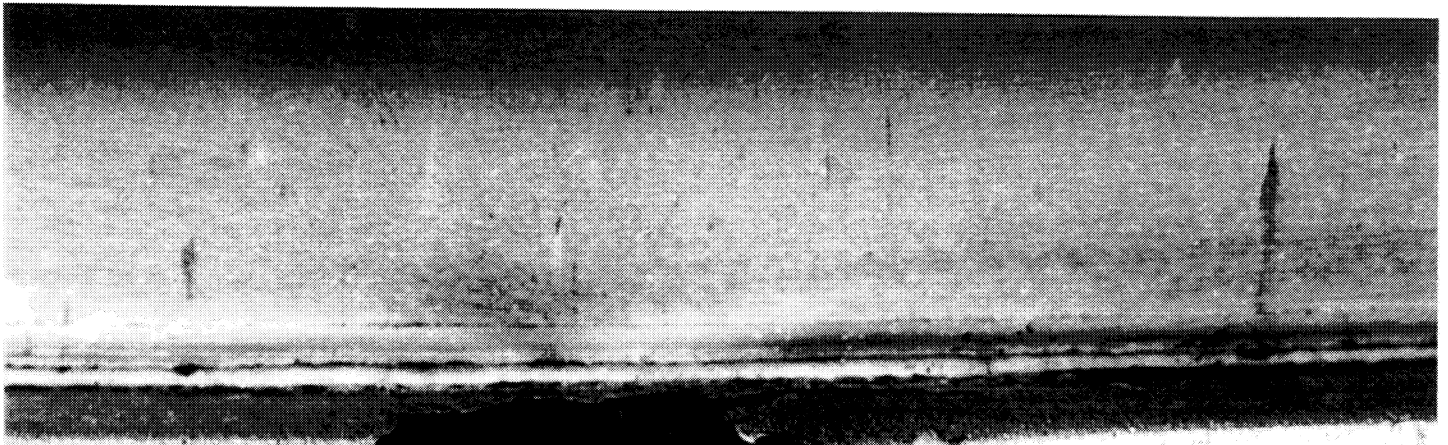
Photo 19: Right Center Joint FJPS Damage

The Field Joint Protection System (FJPS) closeouts were generally in good condition. Trailing edge damage to the FJPS and the GEI cork runs were attributed to debris resulting from severance of the nozzle extension. One area of forward edge cork damage was noted on the right hand center joint at about the 200 degree position. This damage was most probably caused by ice from the ET LO2 feedline forward bellows.

Damage was found on the right hand SRB center joint leading edge at about the 200 degree position. This damage was most probably caused by ice from the ET LO2 feedline forward bellows.

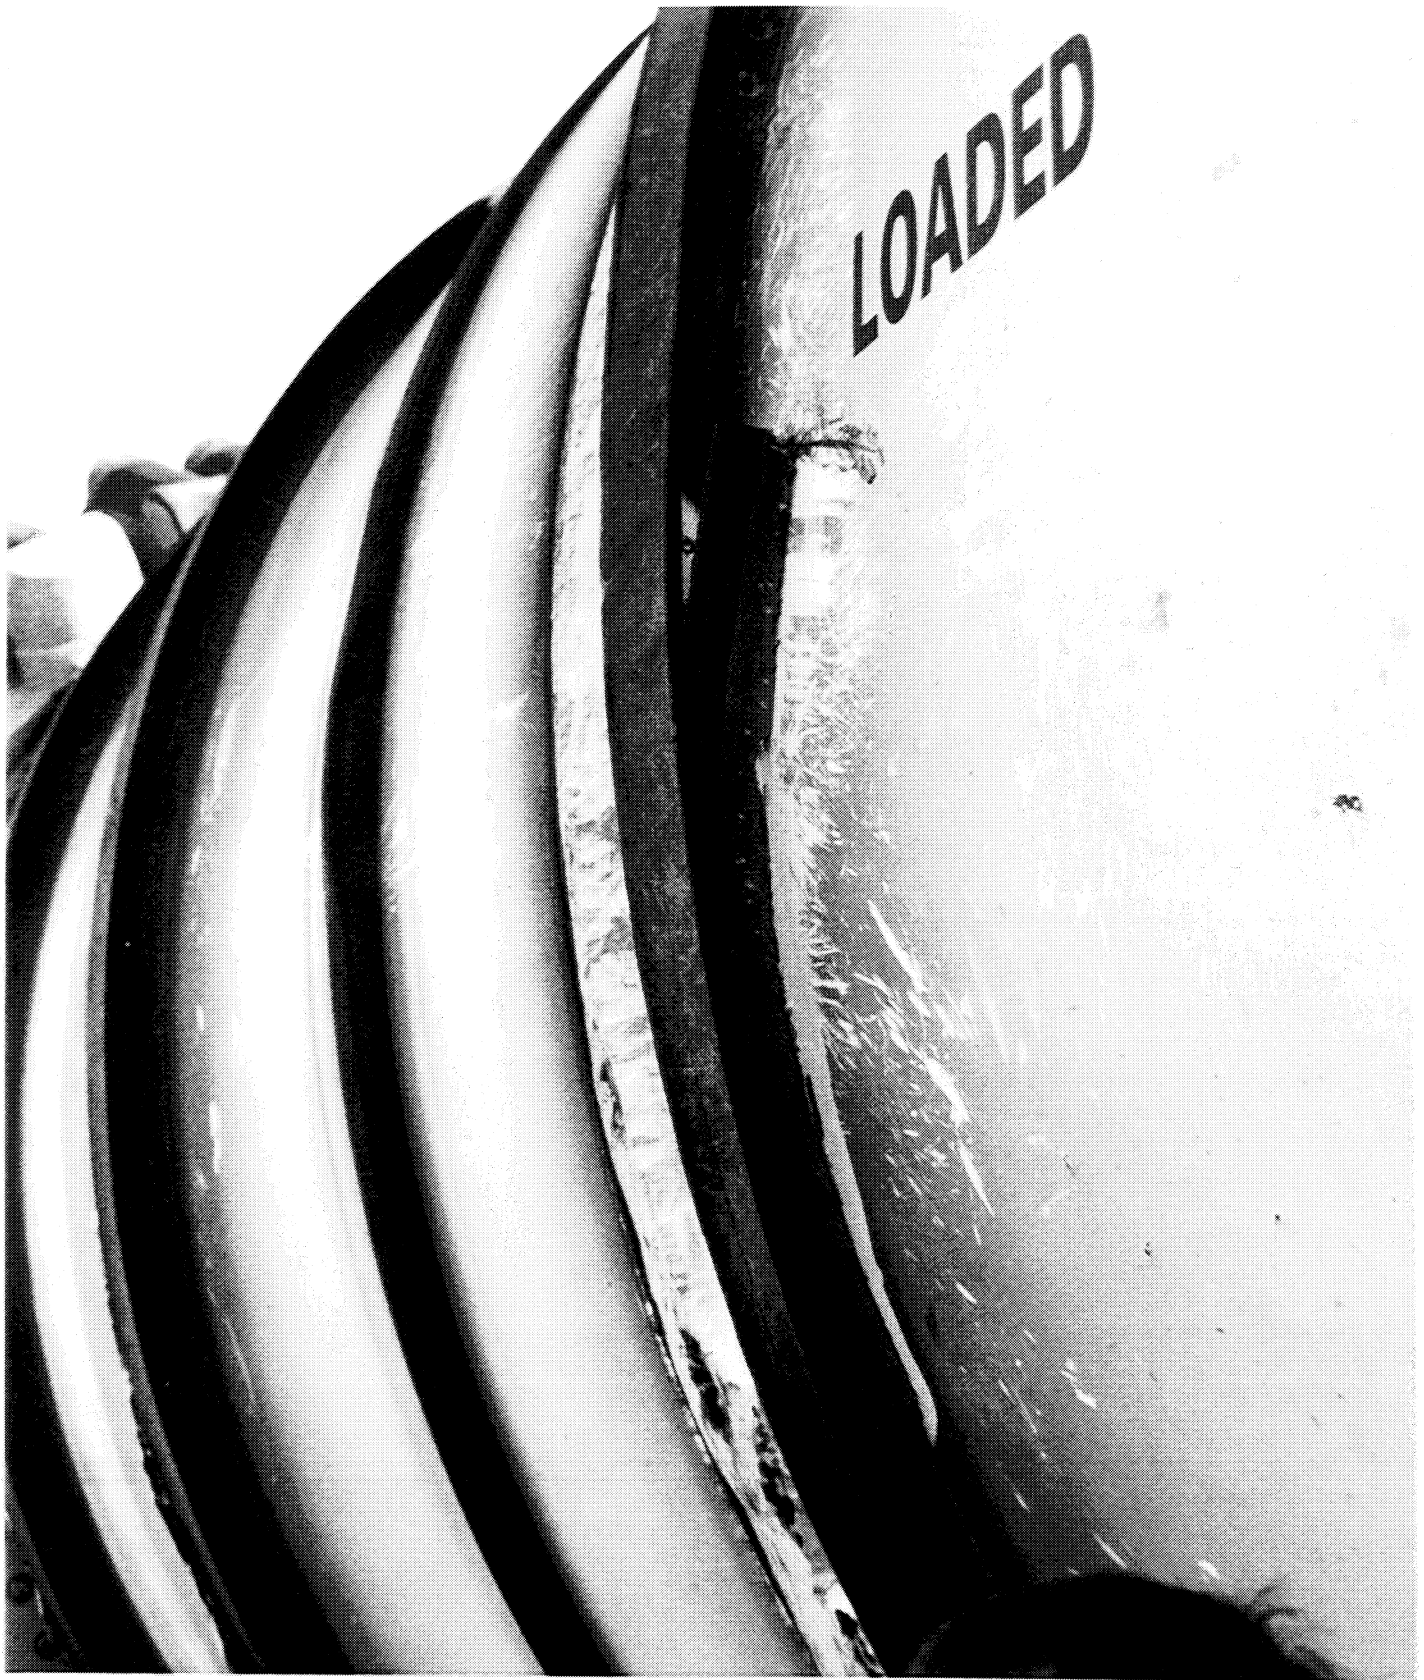
Photo 20: LH SRB Stiffener Ring Damage

The forward stiffener ring on the left booster had been damaged by splashdown. The stiffener ring had separated from the aft booster from approximately 200 to 290 degrees.

The lefthand SRB forward stiffener ring had separated from the aft booster from approximately 200 to 290 degrees. Damage was most likely caused by splashdown.

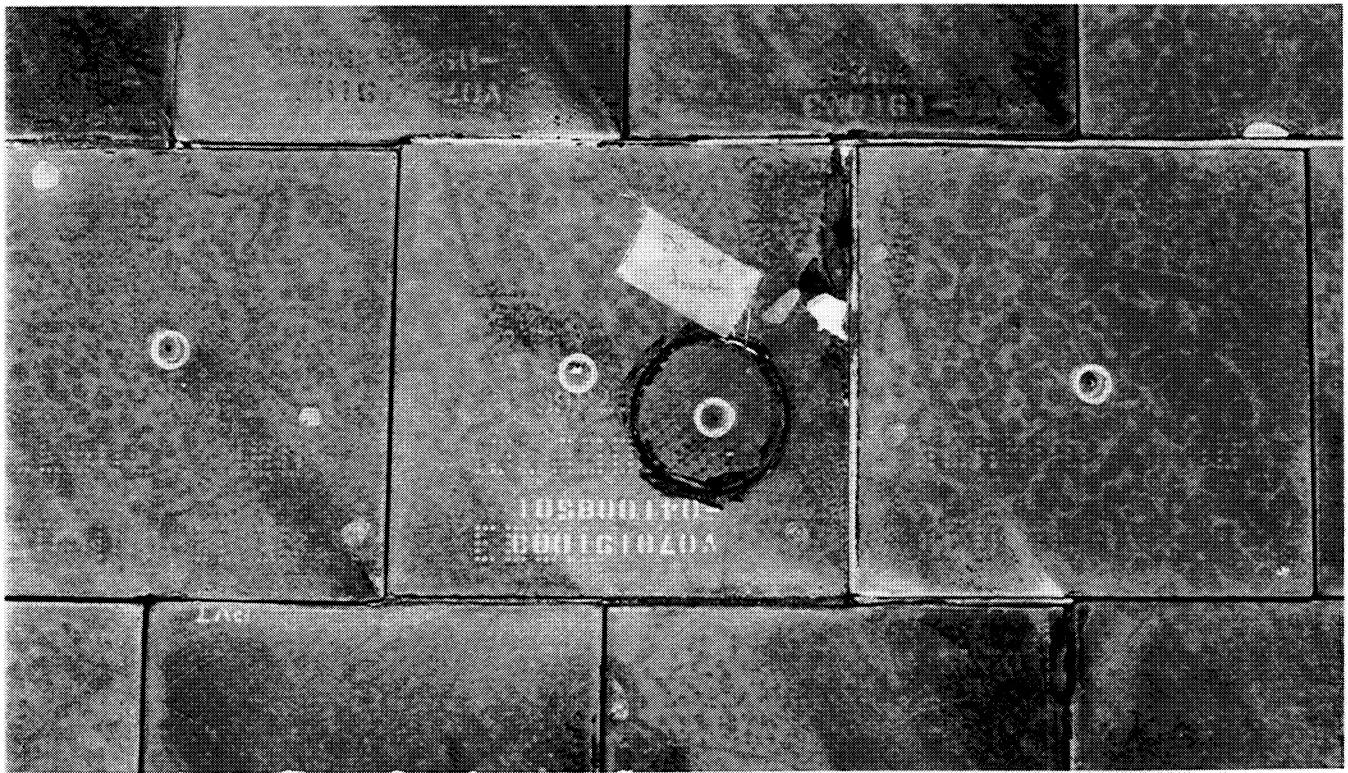
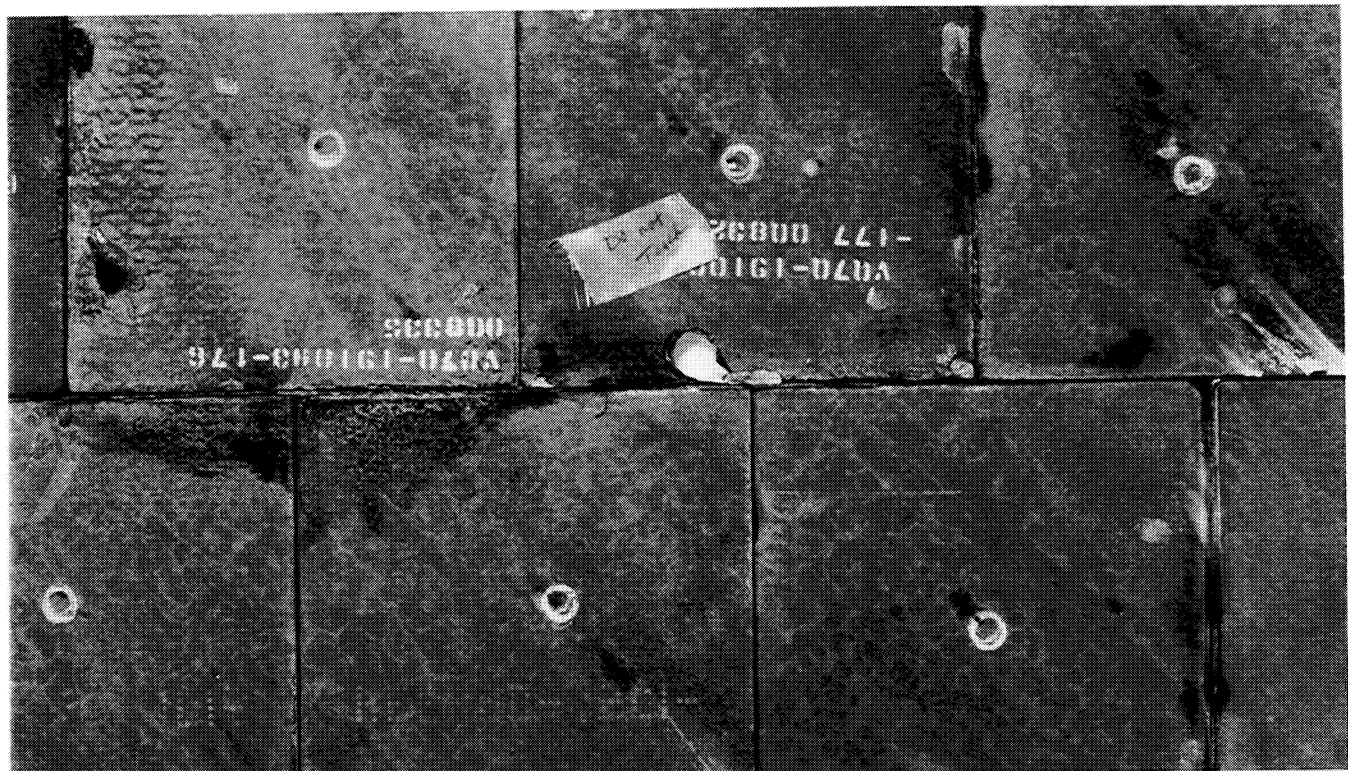
Photo 27: Tile Damage Sites Forward of Right MLG Door

Two tile damage sites forward of the right MLG wheel well (tiles 191003-041 and 191003-177) were originally thought to be candidates for micrometeorite impacts due to the $\frac{3}{4}$ -inch diameter surface openings with larger, deep internal cavities. However, closer inspection in the OPF revealed glazing and erosion, which suggested the impacts occurred during ascent.

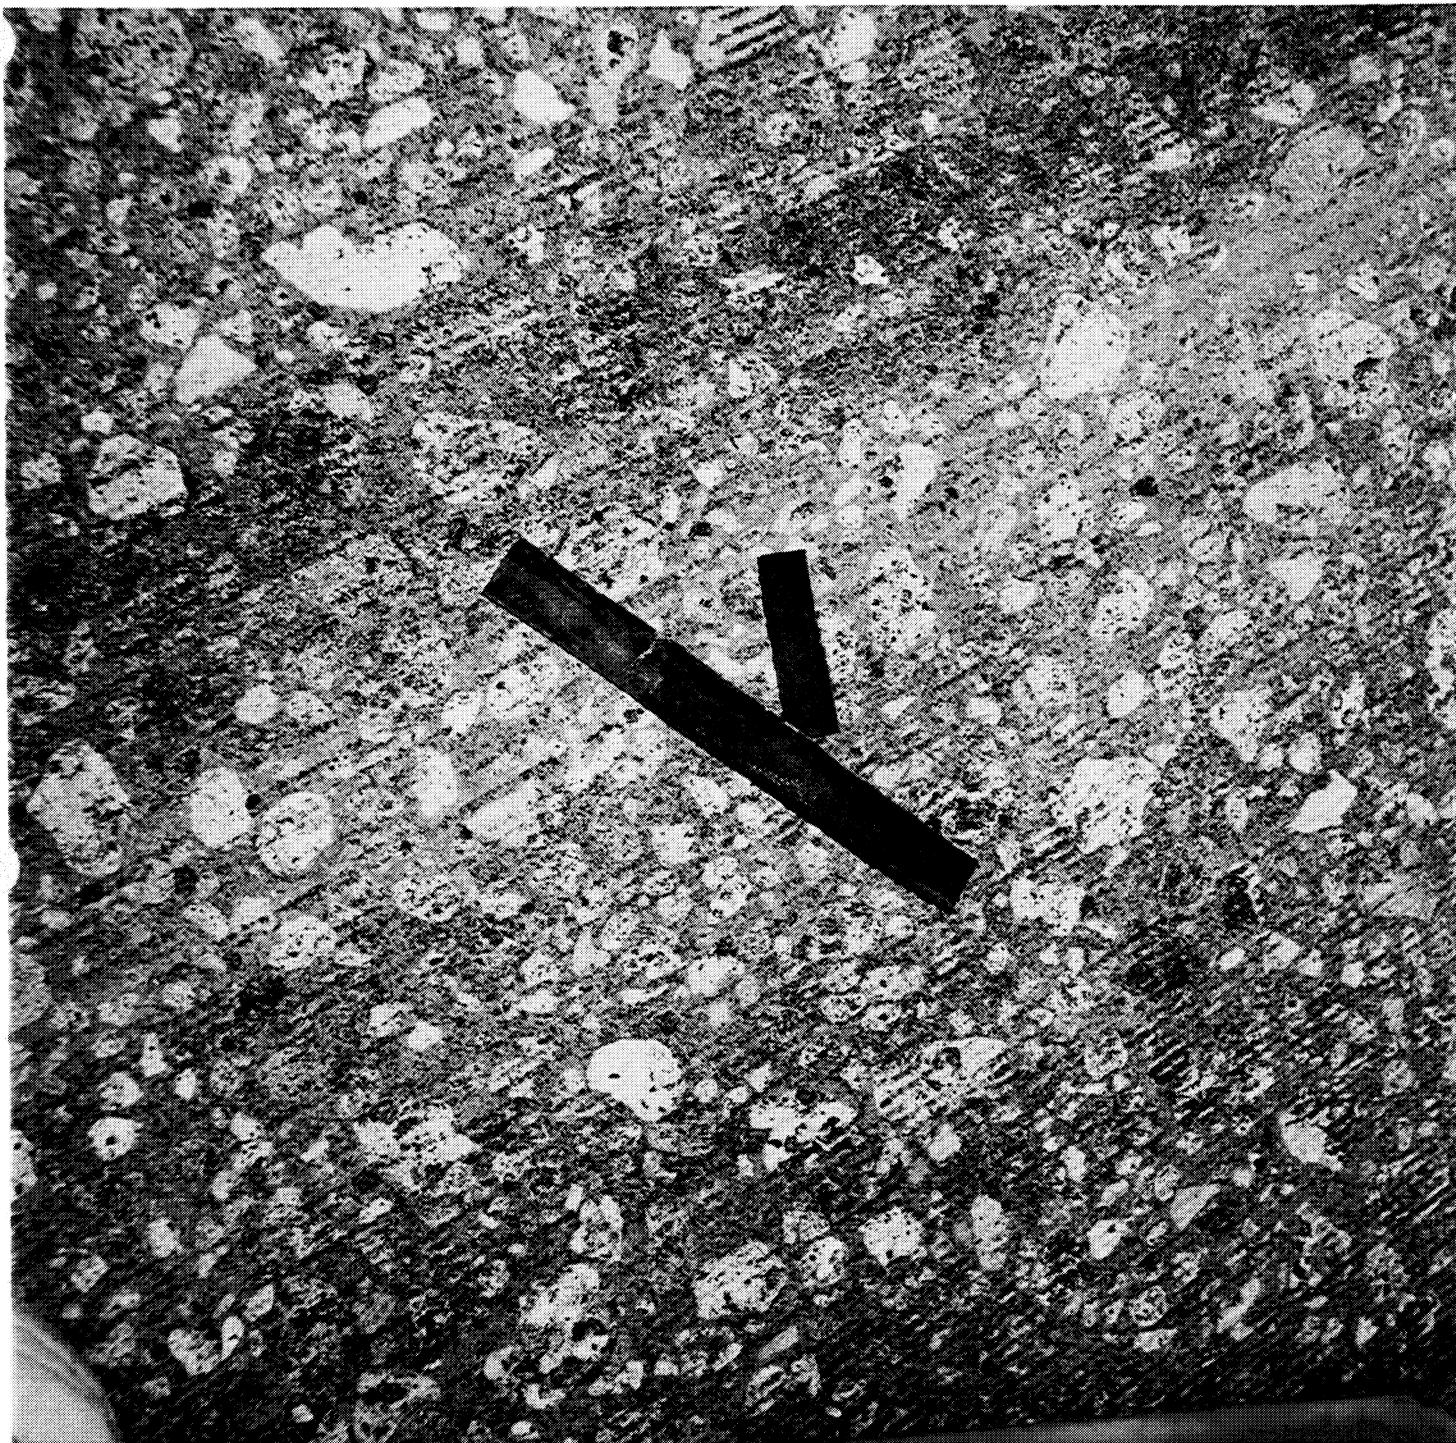
Photo 30: Ames Tile Gap Fillers Found on Runway

Three Ames tile gap fillers were found on the runway generally below the right inboard elevon at the Orbiter wheel-stop point. However, the thin gap fillers most likely originated from some place near the nose or nose landing gear doors.

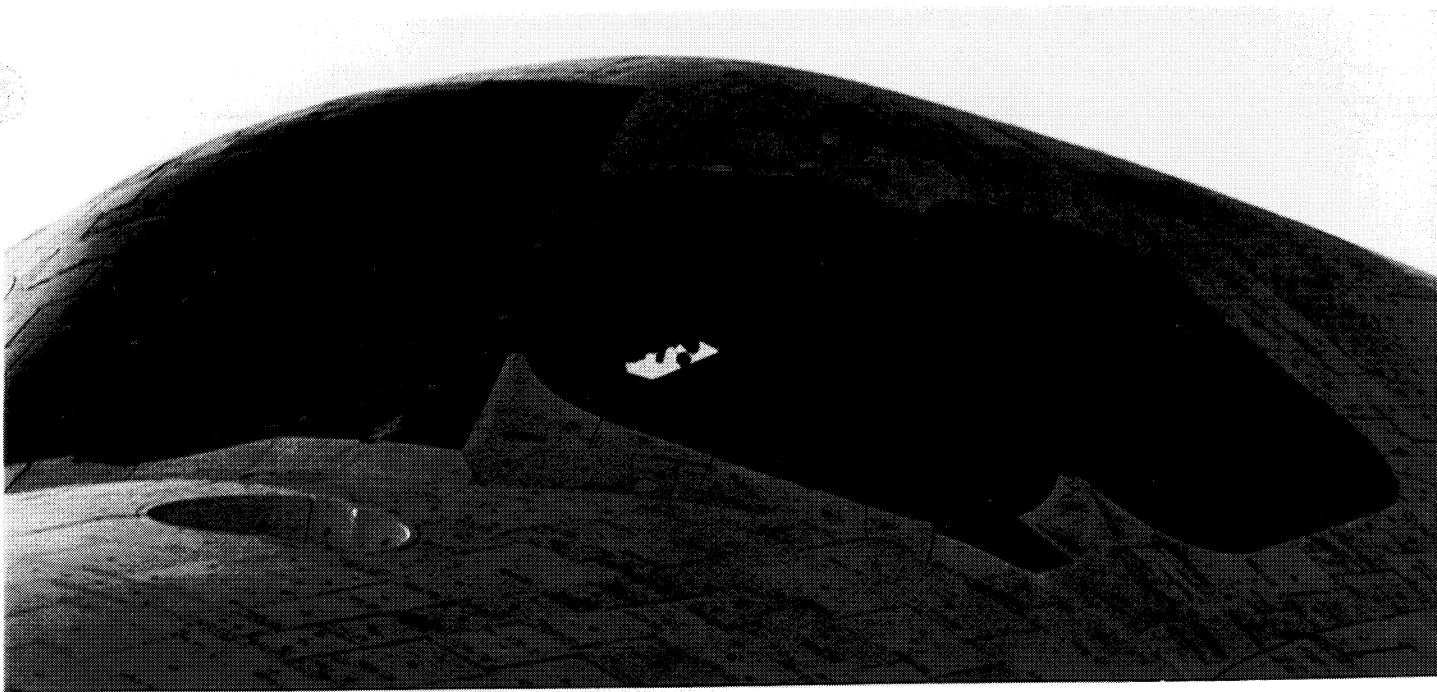
Photo 31: Windows 1 - 3

A 7.5-inch long by 1.8-inch wide by 0.2-inch deep impact was found forward of Window #3. This damage site spanned the 391020-453 white tile and two unidentified adjacent black tiles. These damage sites are believed to be the result of impacts from excessive RTV adhesive used in attaching paper covers to the FRCS thrusters. In fact, a 2-inch long scorched piece of FRCS thruster paper cover was wedged between the window #2 glass and perimeter tiles adjacent to three tile damage sites.

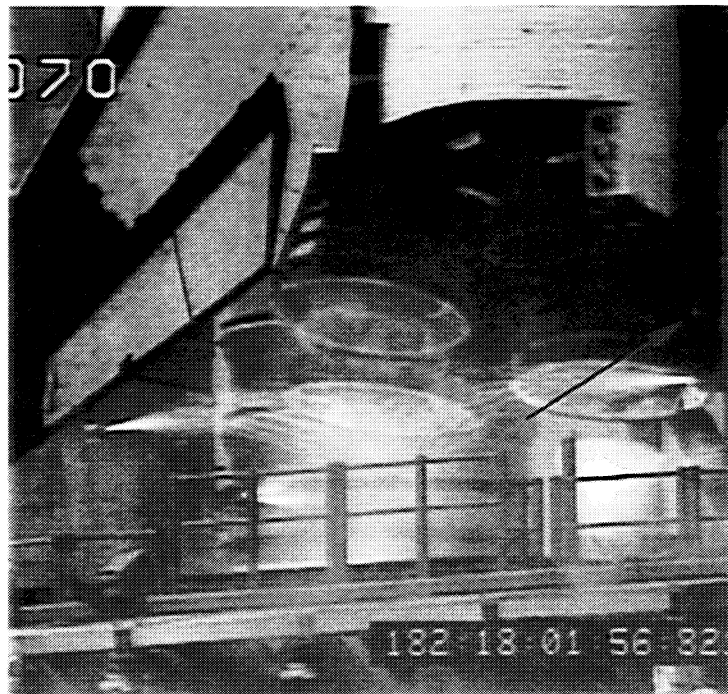
Figure 2.1 (A) Light-colored Debris near RSRB Stinger during SSME Ignition

A single piece of light-colored debris, possibly RCS paper or ice debris, was seen coming from behind the RSRB stinger during SSME ignition (18:01:56.821 UTC) (Cameras OTV070, OTV051).

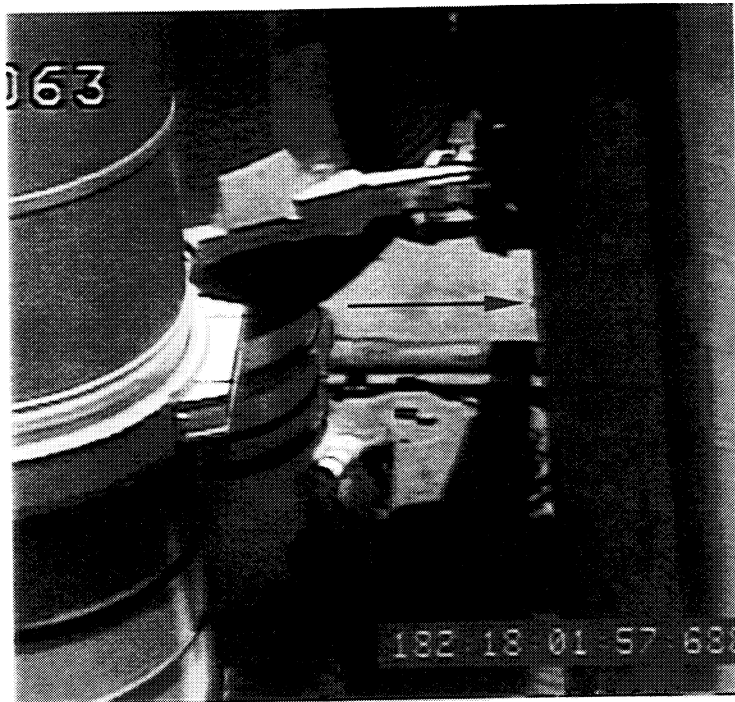
Figure 2.1 (C) Ice Debris Contacts Orbiter Tiles

A single piece of ET/Orbiter umbilical ice debris appeared to contact the Orbiter tiles aft of the ET/Orbiter LH2 umbilical during SSME ignition (18:01:57.688 UTC) (Camera OTV063).

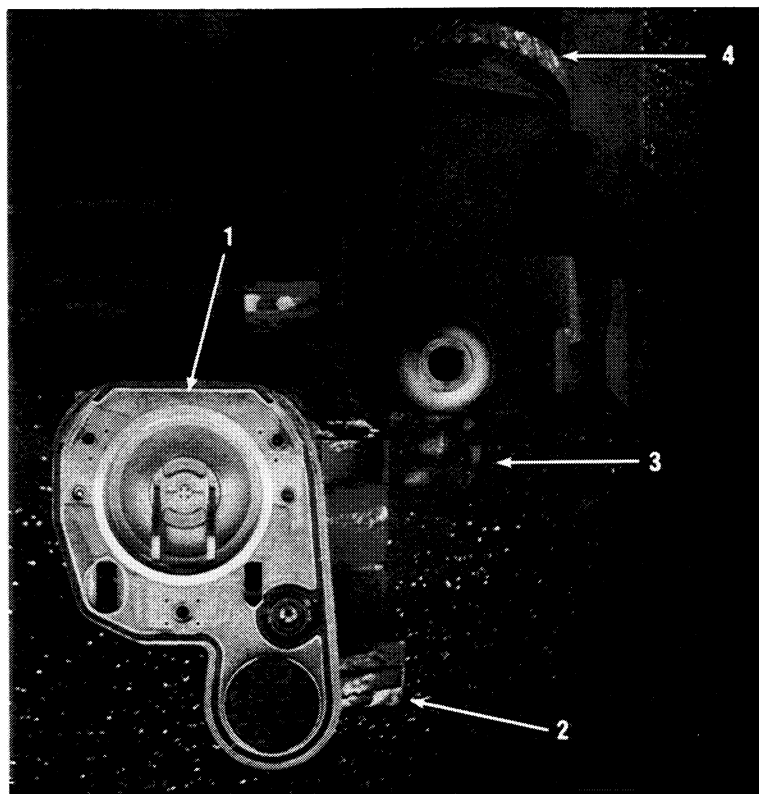
Figure 2.5.1 (A) ET/Orbiter LO2 Umbilical

One of the five lightning contact strips (12 o'clock position) appeared to be missing from the ET/Orbiter LO2 umbilical interface plate (1). KSC reported that STS-94 (ET-86) was the first vehicle to use the new "wire-mesh" electrical contact plates (lightning contact strips) on the LO2 ET/Orbiter umbilical. This new material is similar in form to umbilical foam and can give the appearance that a contact plate is missing. KSC confirmed that all five of the LO2 umbilical contact plates were intact and properly attached.

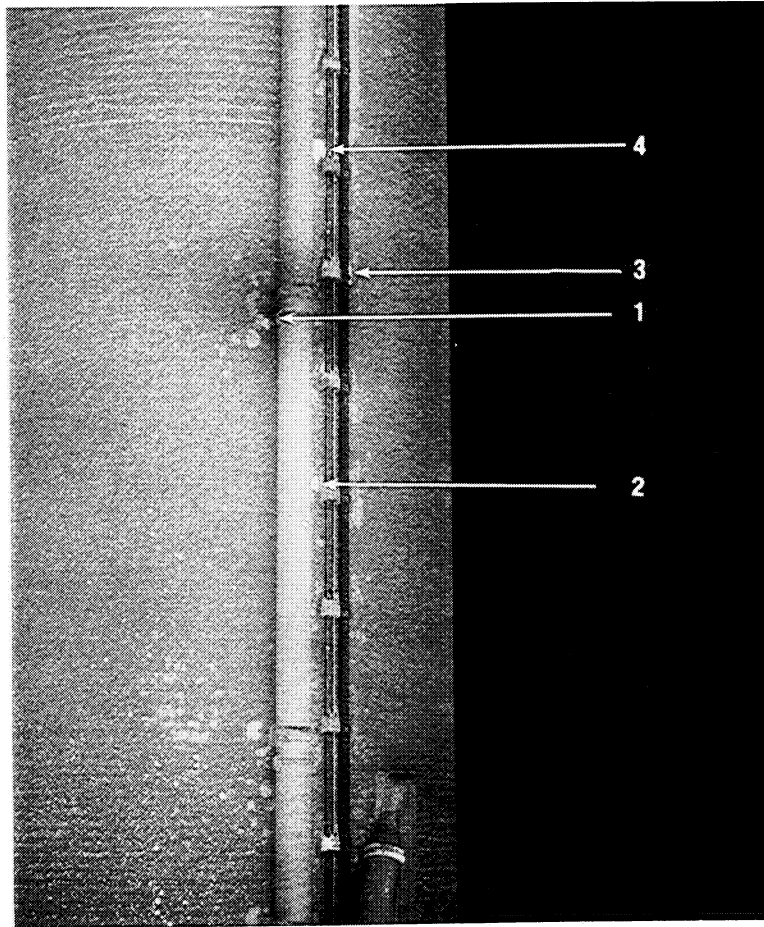
Figure 2.5.1 (B) LH2 Tank Divots

A shallow white mark (divot) approximately four inches in diameter was seen to the left of the LO2 feedline on the LH2 tank TPS at approximately station XT-1623 (1). Several divots were seen near the LH2 tank pressurization line and the LO2 feedline support brackets: a white mark (divot), approximately six inches in size, is visible between the LO2 feedline and the electric cable tray forward of the +Y thrust strut at approximate station XT 1722 (2), a 14-inch long divot was noted outboard (+Y) of the electric cable tray ramp at approximate station 1593 (3), and a 16-inch long divot was visible between the LO2 feedline and the pressurization line at approximate station XT 1528 (4).

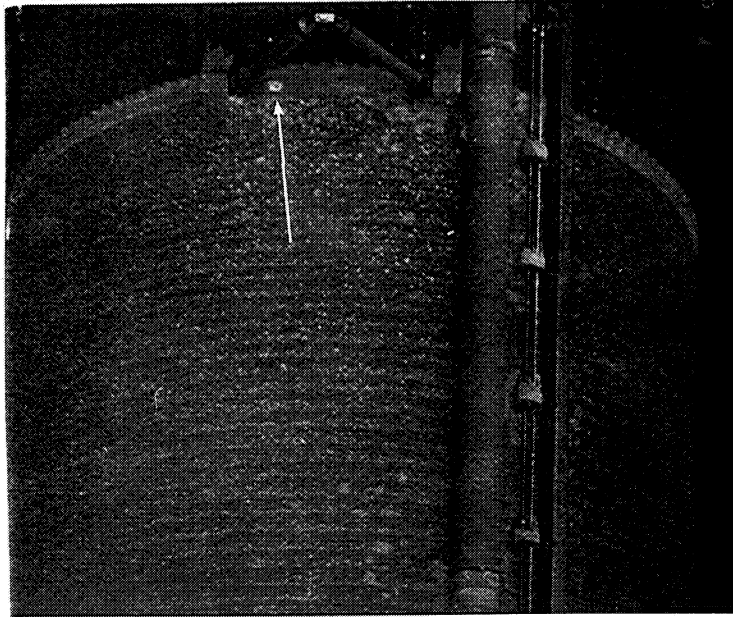
Figure 2.5.1 (C) -Y Jackpad Close-out Divot

An approximately four-inch diameter divot with primer visible was seen by the ET/Orbiter attach -Y bipod jackpad close-out. Several small (one-inch diameter) intertank stringer-head divots were visible forward of the right leg of the ET/Orbiter attach bipod.

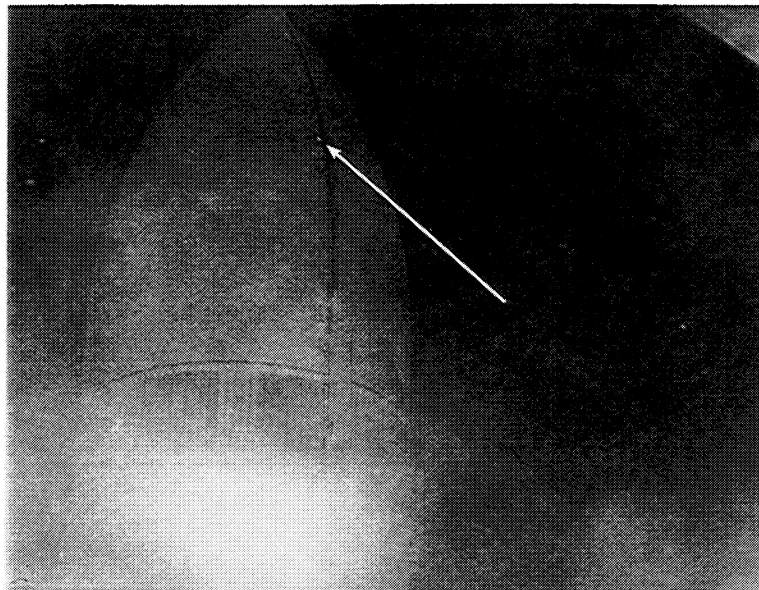
Figure 2.5.1 (D) White Mark (Possible Divot) on ET Nose

A small, white mark (divot) was seen on the ET nose to the left of the electric cable tray. The PAL ramp and the LO2 feedline fairing appeared normal.
